Report on Structural Integrity of Light Poles

Date: 12/8/2019

Purpose of Study

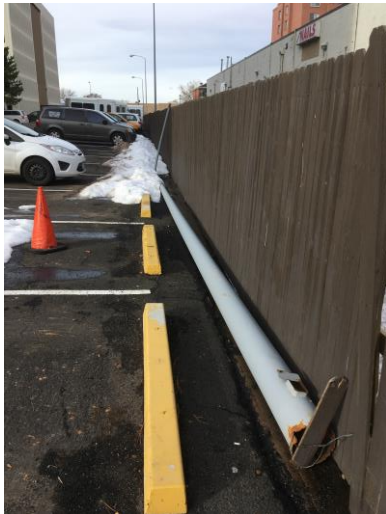
The property contains 18 light poles in the parking facility. One of these poles failed and collapsed (Figure 1). An examination of the failed pole found extensive rusting around the base of the pole, indicating that water had likely been pooling inside the pole and causing it to rust from the inside out (Figures 2 and 3).

Figure 1: Downed light pole on NE corner of the property.

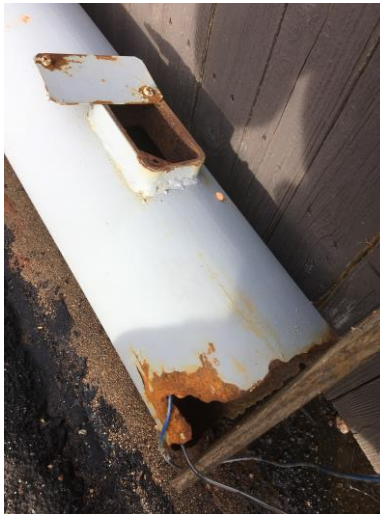
Figure 2: Rusting visible at base of downed pole.

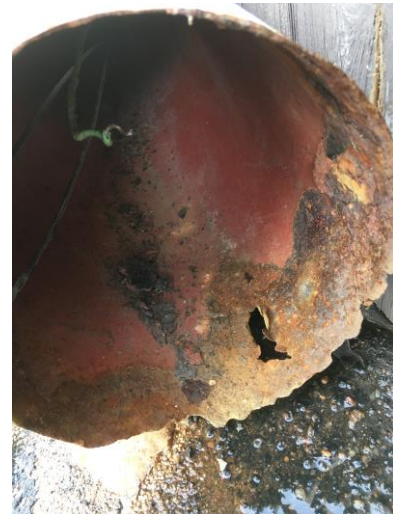
Figure 3: Internal view of rusting at base of downed pole.

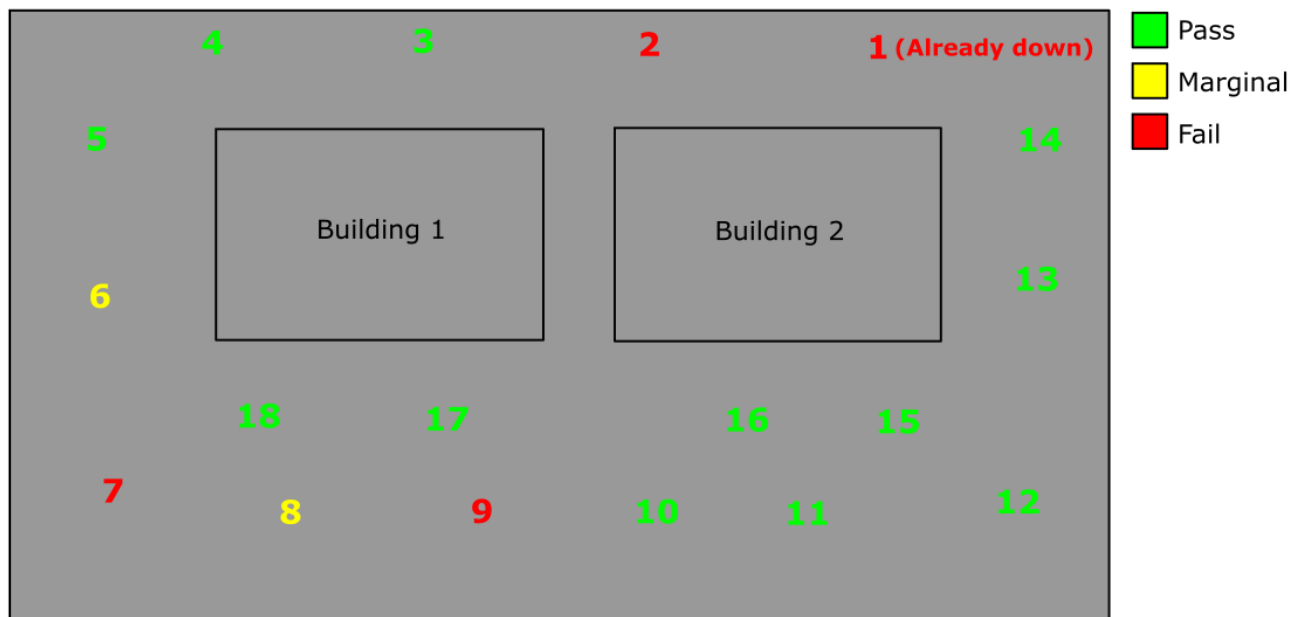
The map (Figure 4) shows the locations of the numbered poles and indicates which poles received a rating of pass (green), marginal (yellow), or fail (red). Note that pole number 1 indicates the pole which already fell down.

Figure 4: Map of light pole locations.

- Poles 2, 6, 7, 8, and 9 should be replaced or repaired.
- If the owner wishes to repair the poles rather than replacing them, ES Denver may be contracted to design a repair plan.
- The property owner should perform regular visual inspections of all light pole bases to look for any visible signs of rusting. If visible rusting develops in the future on any pole, ES Denver should be notified to perform a follow-up inspection.

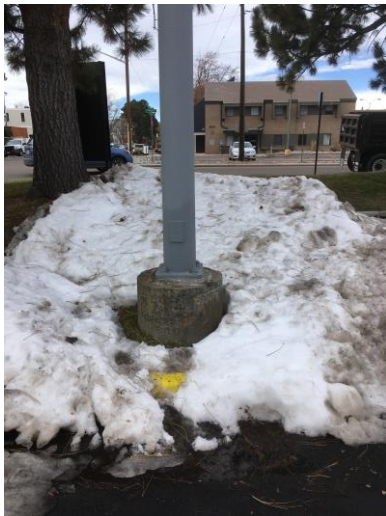
Additionally, it was observed that several light poles were surrounded by large snow piles from plowing of the parking lot (Figures 5 & 6). Given that the last snowstorm occurred more than a week prior to this observation, it seems likely that these poles were at one time buried in snow above the height of the concrete pedestal. Burial of the pole in snow above the concrete pedestal may be a contributing factor to water penetrating the light pole base. It is recommended that the snow plowing procedures of the parking lot be modified to prevent burial of the concrete pedestals.

Figure 5: Pole number 7 with large pile of snow plowed around the base.

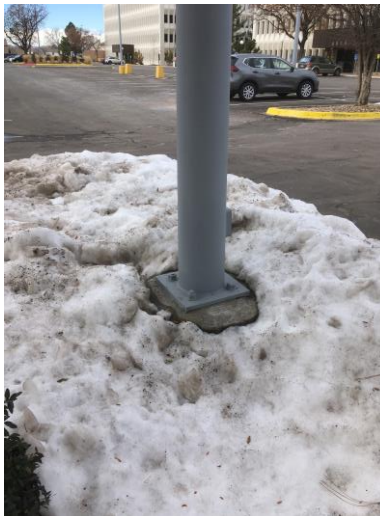
Figure 6: Pole number 12 with large pile of snow plowed around the base.

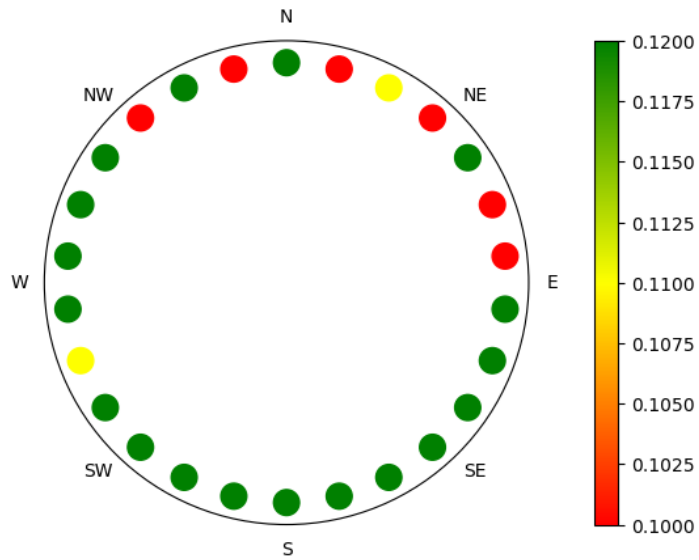
POLE #2

Observations: Minor rusting visible on north side.

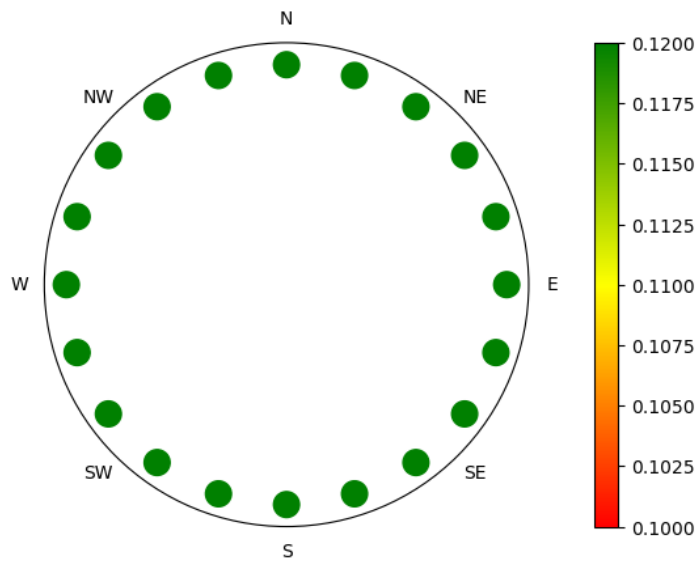
POLE #3

Observations: No visible rusting.

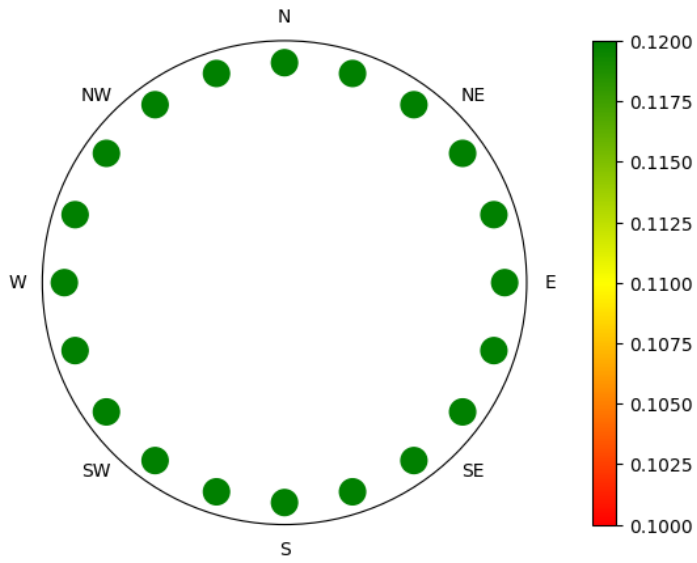
POLE #4

Observations: No visible rusting.

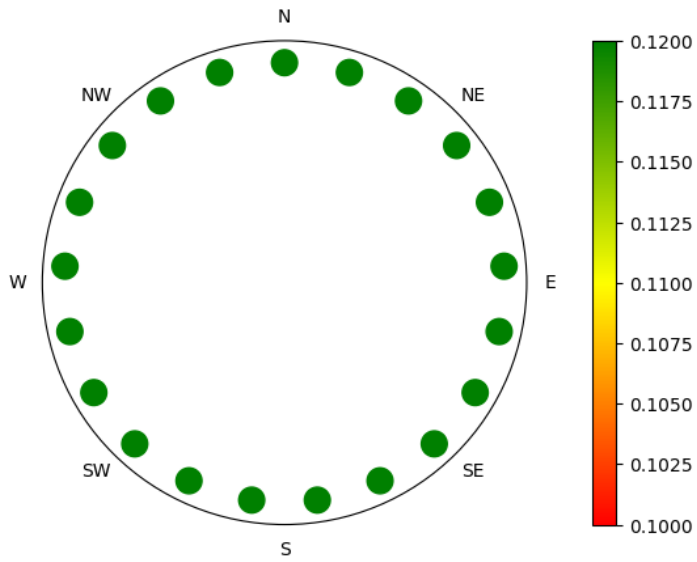
POLE #5

Observations: No visible rusting.

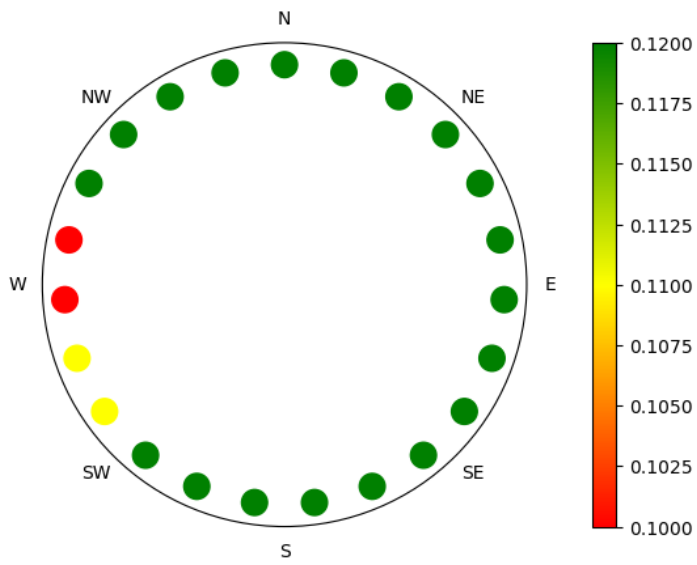
POLE #6

Observations: No visible rusting.

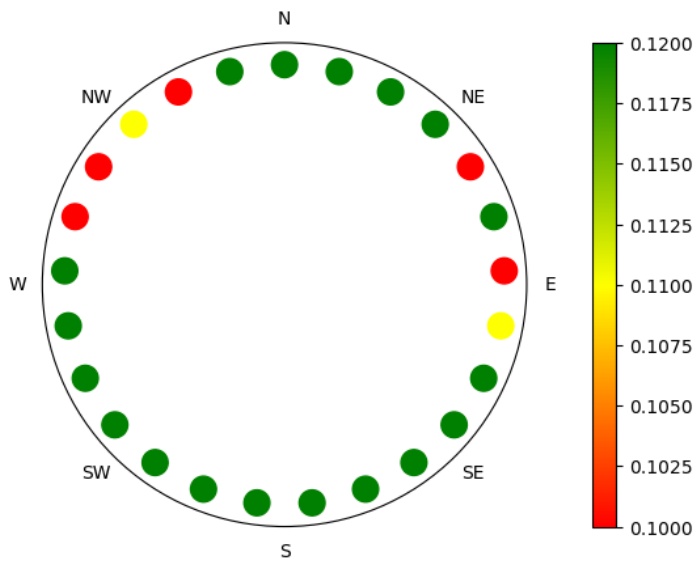
POLE #7

Observations: Extensive rusting visible on west side and minor rusting visible on north side.

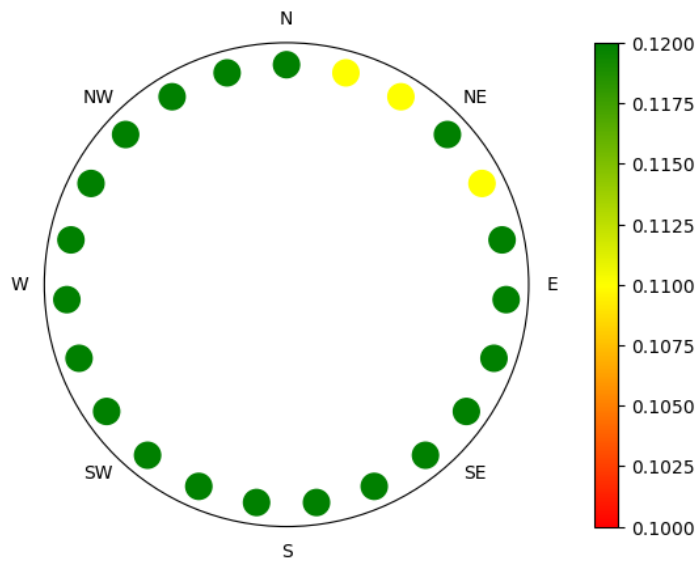
POLE #8

Observations: No visible rusting.

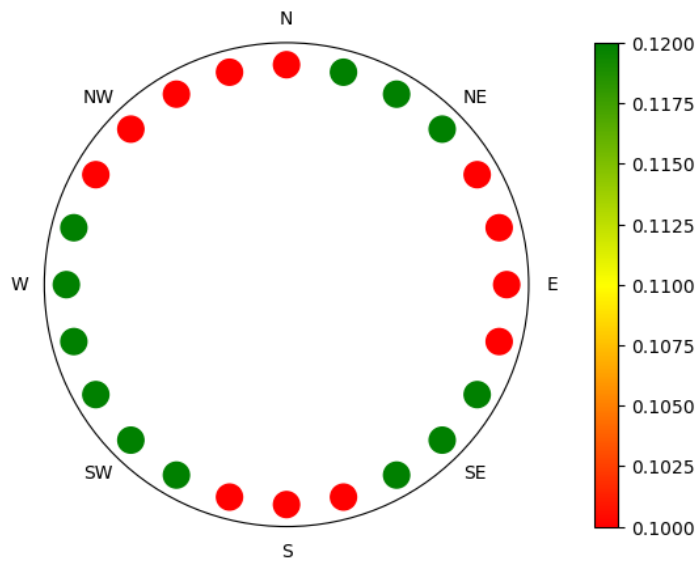
POLE #9

Observations: Extensive rusting visible on south side.

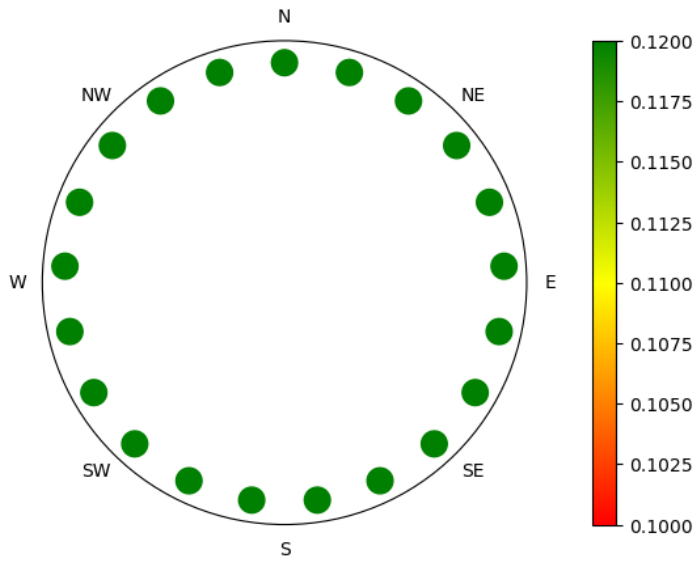
POLE #10

Observations: No visible rusting.

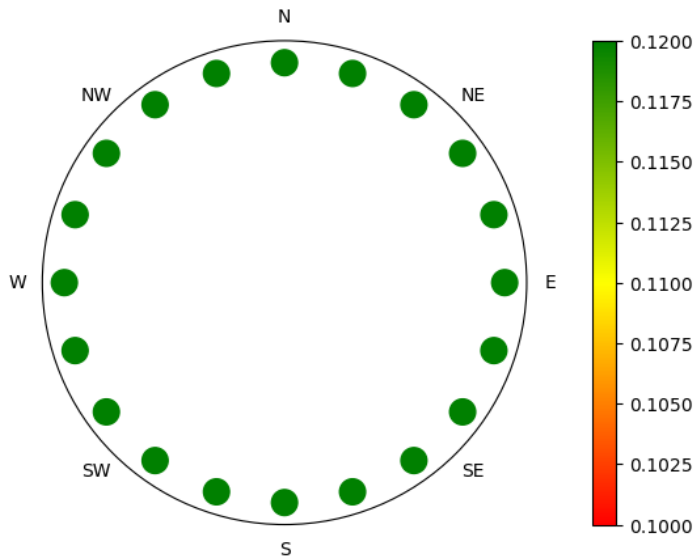
POLE #11

Observations: No visible rusting.

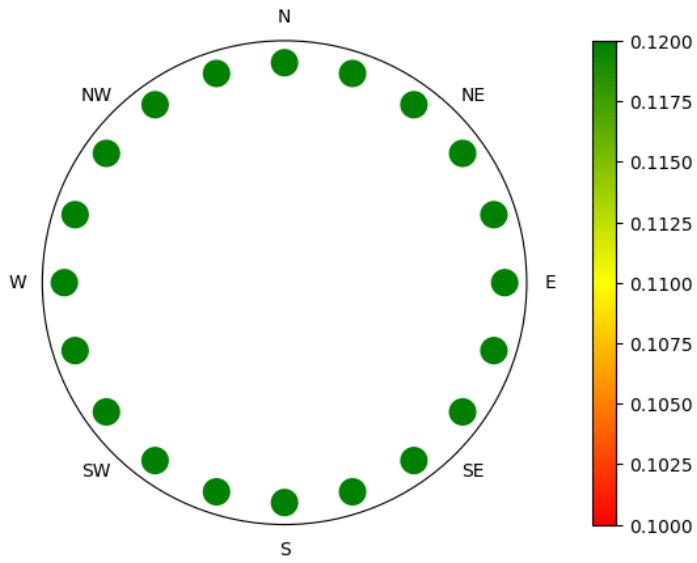
POLE #12

Observations: No visible rusting.

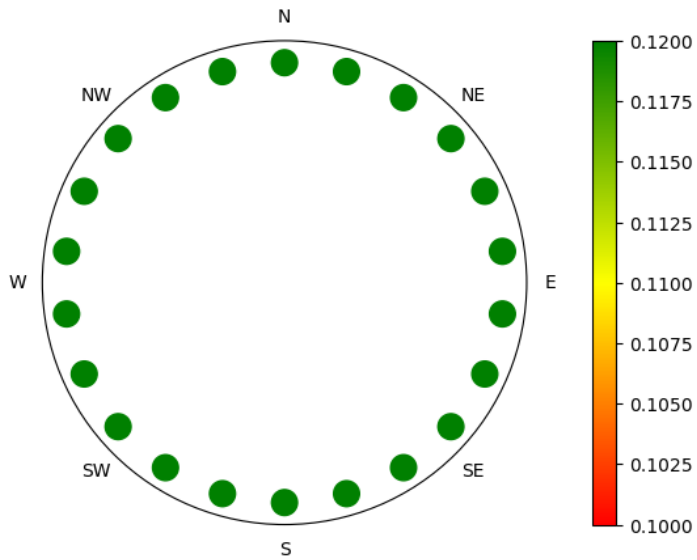
POLE #13

Observations: No visible rusting.

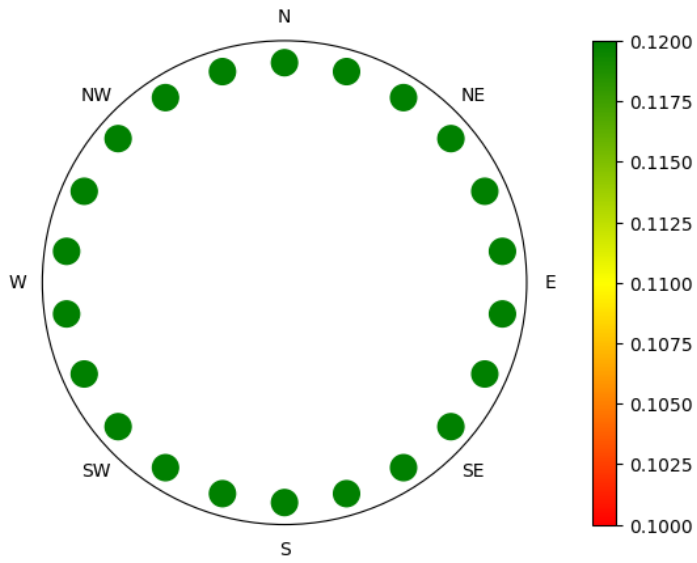
POLE #14

Observations: No visible rusting.

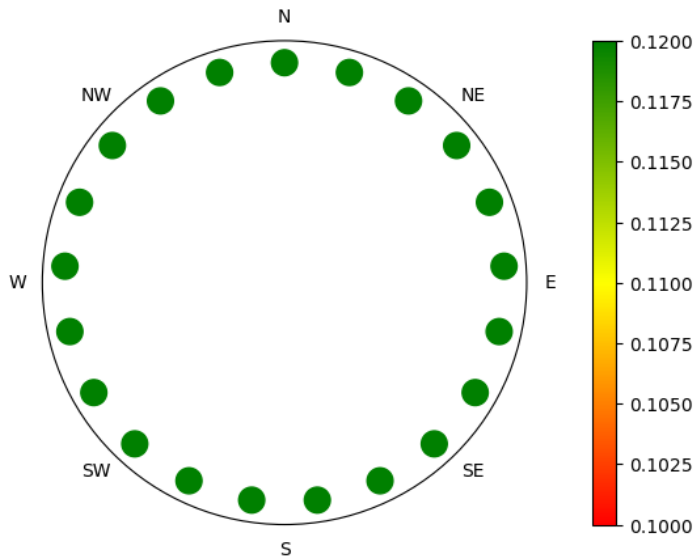
POLE #15

Observations: No visible rusting.

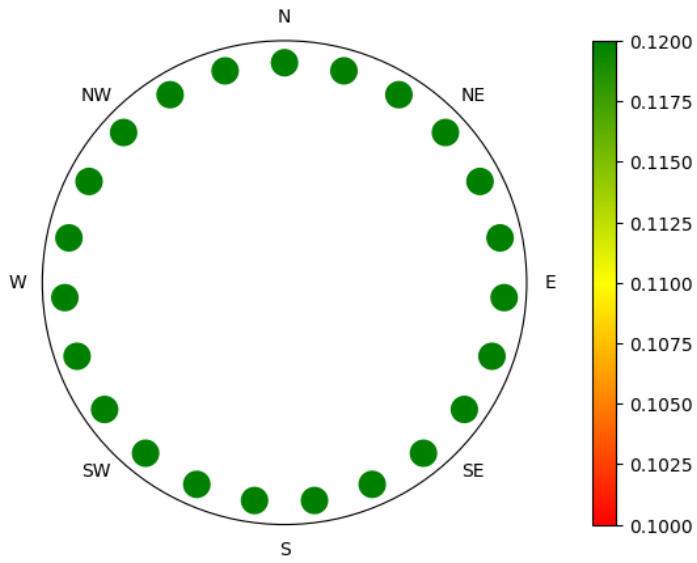
POLE #16

Observations: No visible rusting.

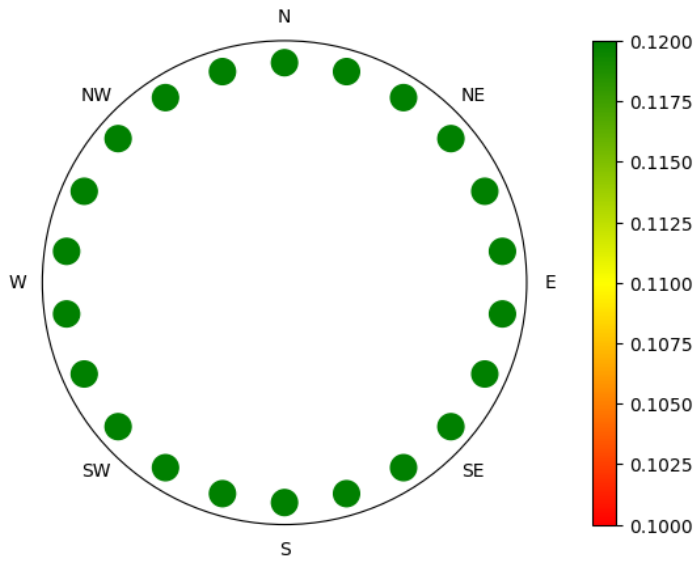
POLE #17

Observations: No visible rusting.

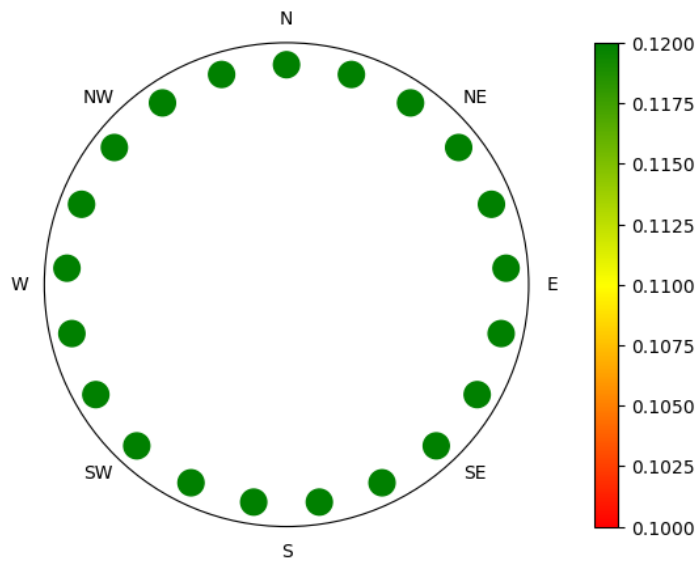
POLE #18

Observations: No visible rusting.
